Investigation of Concrete Bridge Deck Cracking

Wiss, Janney, Elstner Associates, Inc.

Todd Nelson, P.E. – Associate Principal

February 27 and 28, 2018

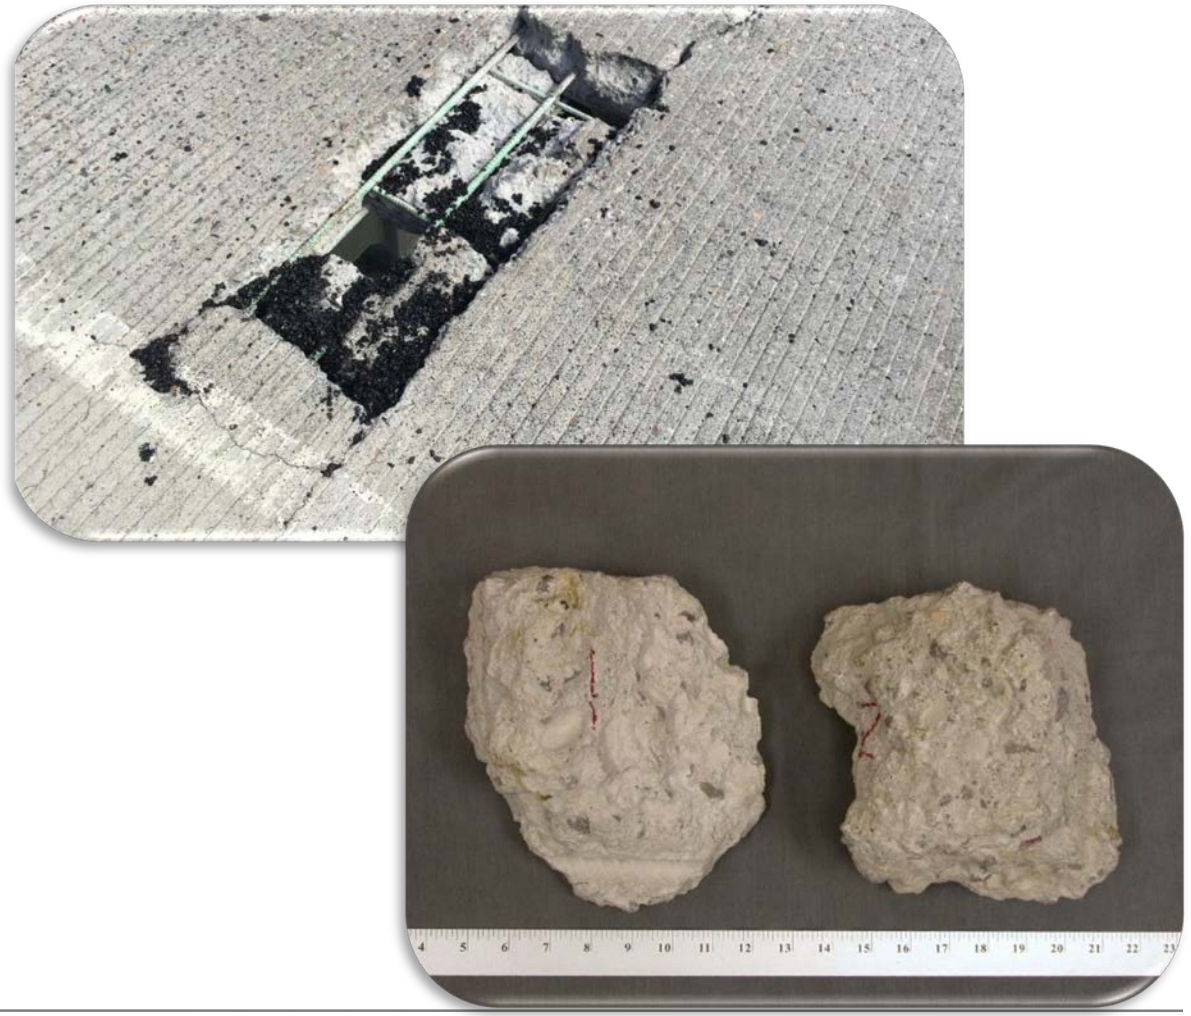
Project Background – Preliminary Lab Studies

- Concrete chunks were retrieved from MDT – fallen from LZ
- Based on photographs and information provided by MDT – WJE's original hypothesis - materials deterioration
- WJE performed preliminary petrographic analyses and chemistry
- Focus on any material related distress

- No signs of internal distress (ASR, Freeze/Thaw, chemical attack, etc.)
- Aggregate quality good
- W/cm adequate
- High air content – 9 to 12 %
- White glaze on steel imprint and fractured surfaces
  - Consistent with leaching of the cement paste
- Weak paste-to-aggregate bond
- No direct contributing cause(s) to the cracking/deck penetration

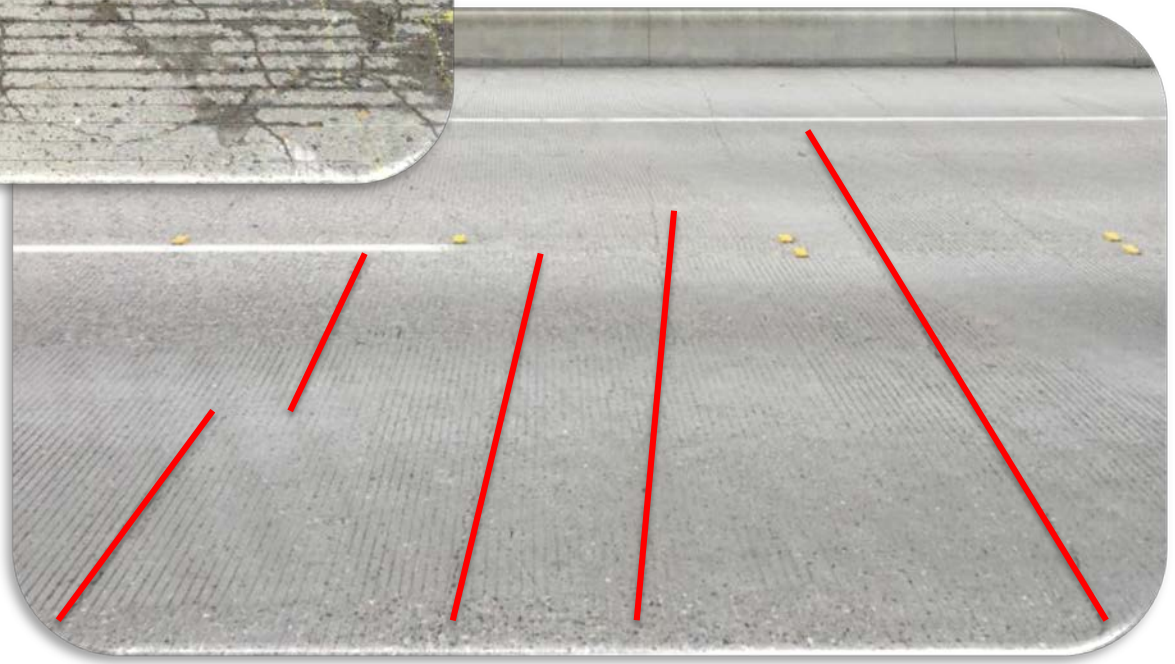
Map cracking

Transverse cracking

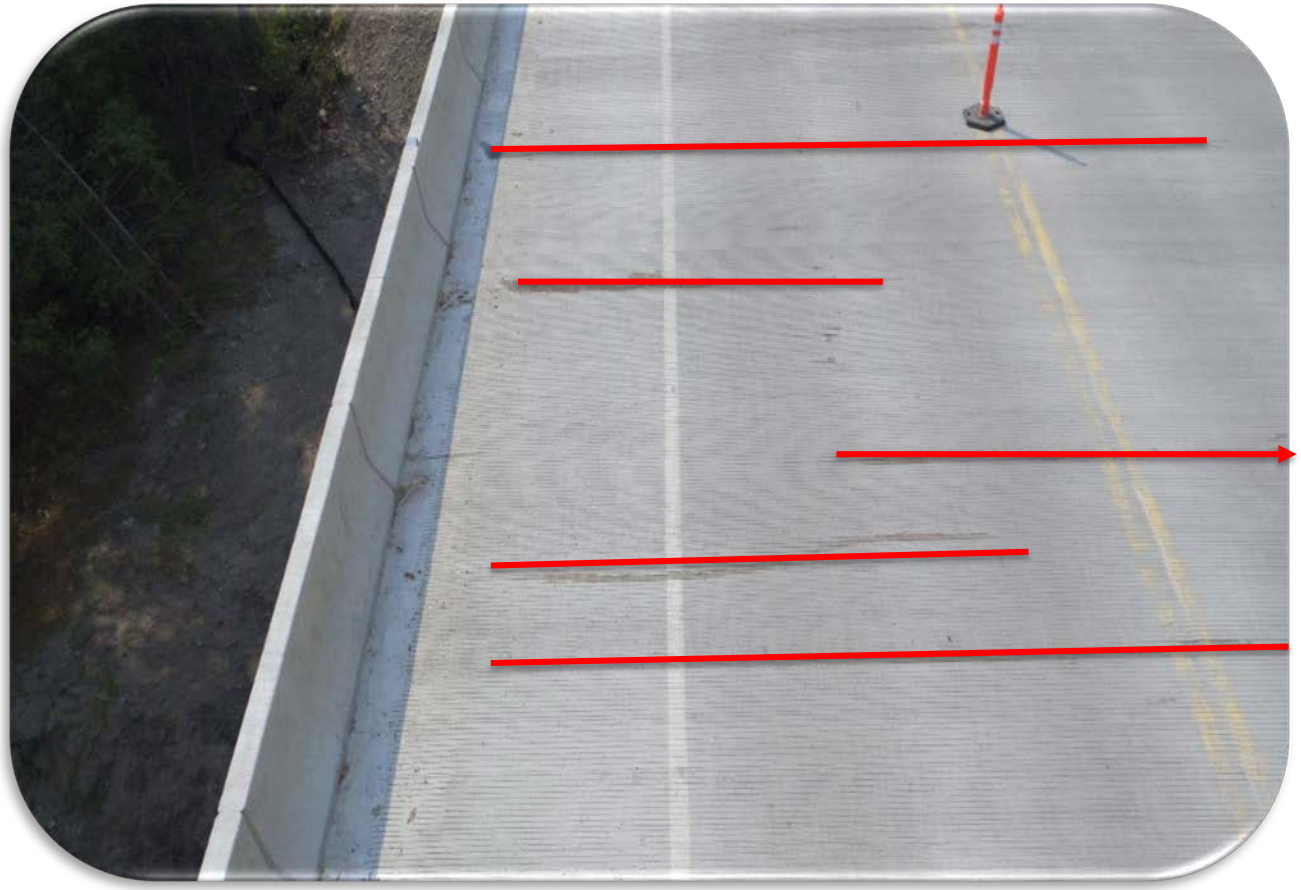
Transverse cracking

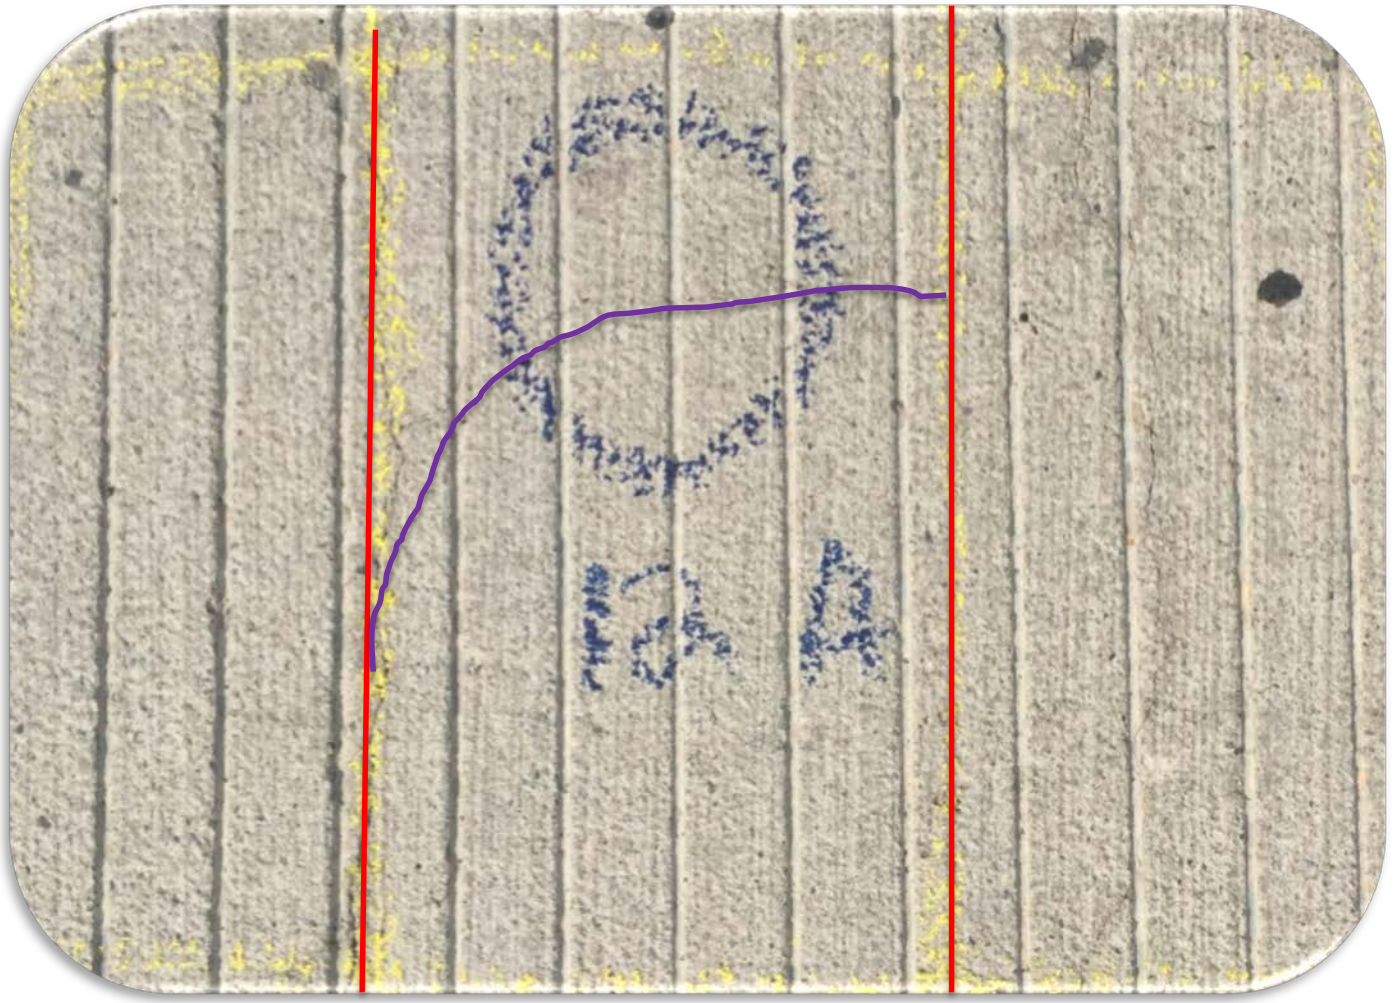
"Jump" cracking

- Hypothesis on crack progression:
  1. Transverse cracks develop, likely early
  2. Transverse cracks progress over time
  3. Closely-spaced transverse cracks form "jump" cracks
  4. Continued volumetric movement and traffic loading - widen and ravel transverse and "jump" crack
  5. Deck penetrations may develop at "jump" cracks with the right conditions:
     - Deck penetrations more prone to occur with top and bottom mats aligned
     - The more closely spaced the transverse cracks, the more likely deck penetrations will occur
     - Driving lanes and under wheel paths more susceptible

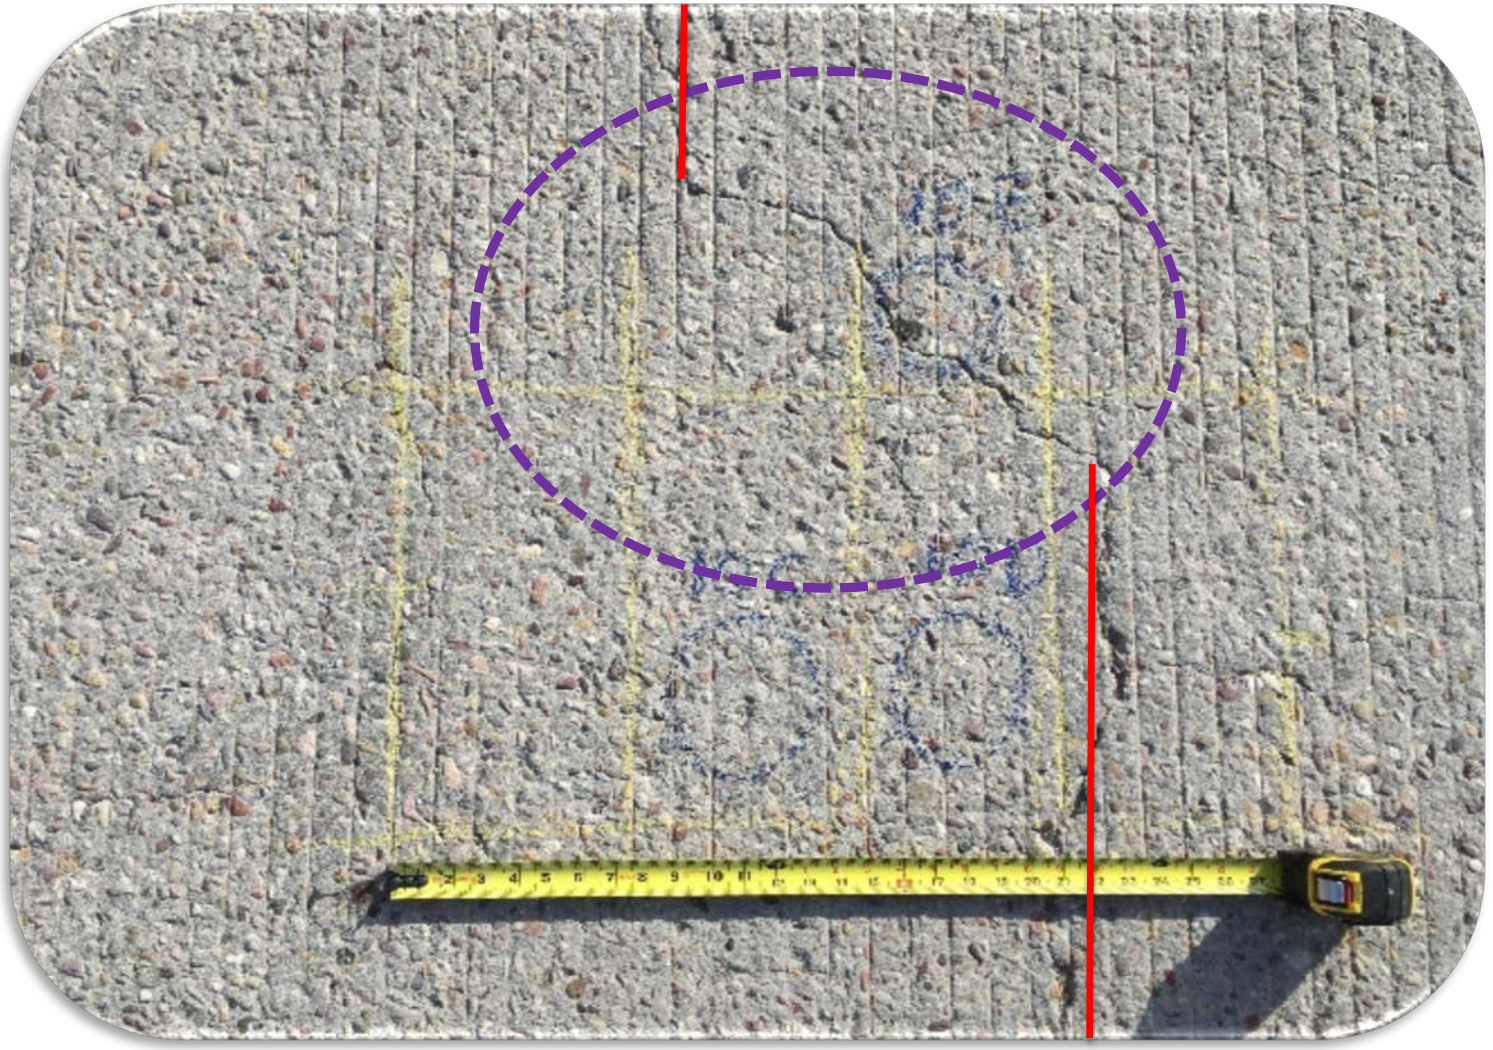
Field Investigation – Deck Penetration

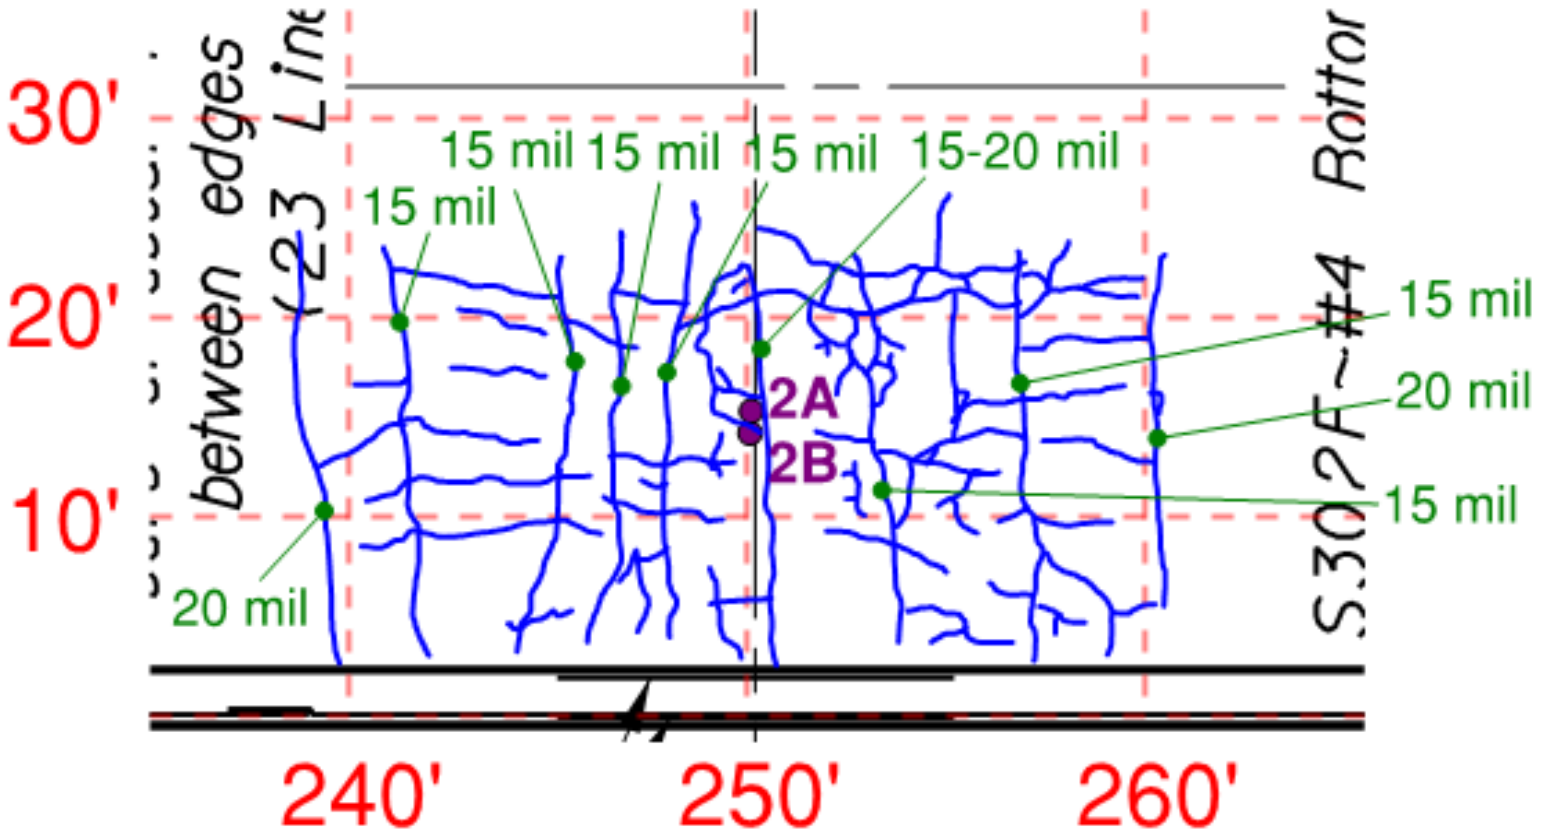
- Transverse crack spacing varied from 2 to 4 feet on most bridges
  - More frequent then typical
- Transverse cracks predominately over transverse bars (GPR)
- Width of transverse cracks were typically 15 to 25 mils
- Plastic shrinkage cracking noted on some decks, most severe on Florence-East MP 10.640 - 1 year old and contained silica fume concrete.
- Longitudinal cracking noted, but not significant

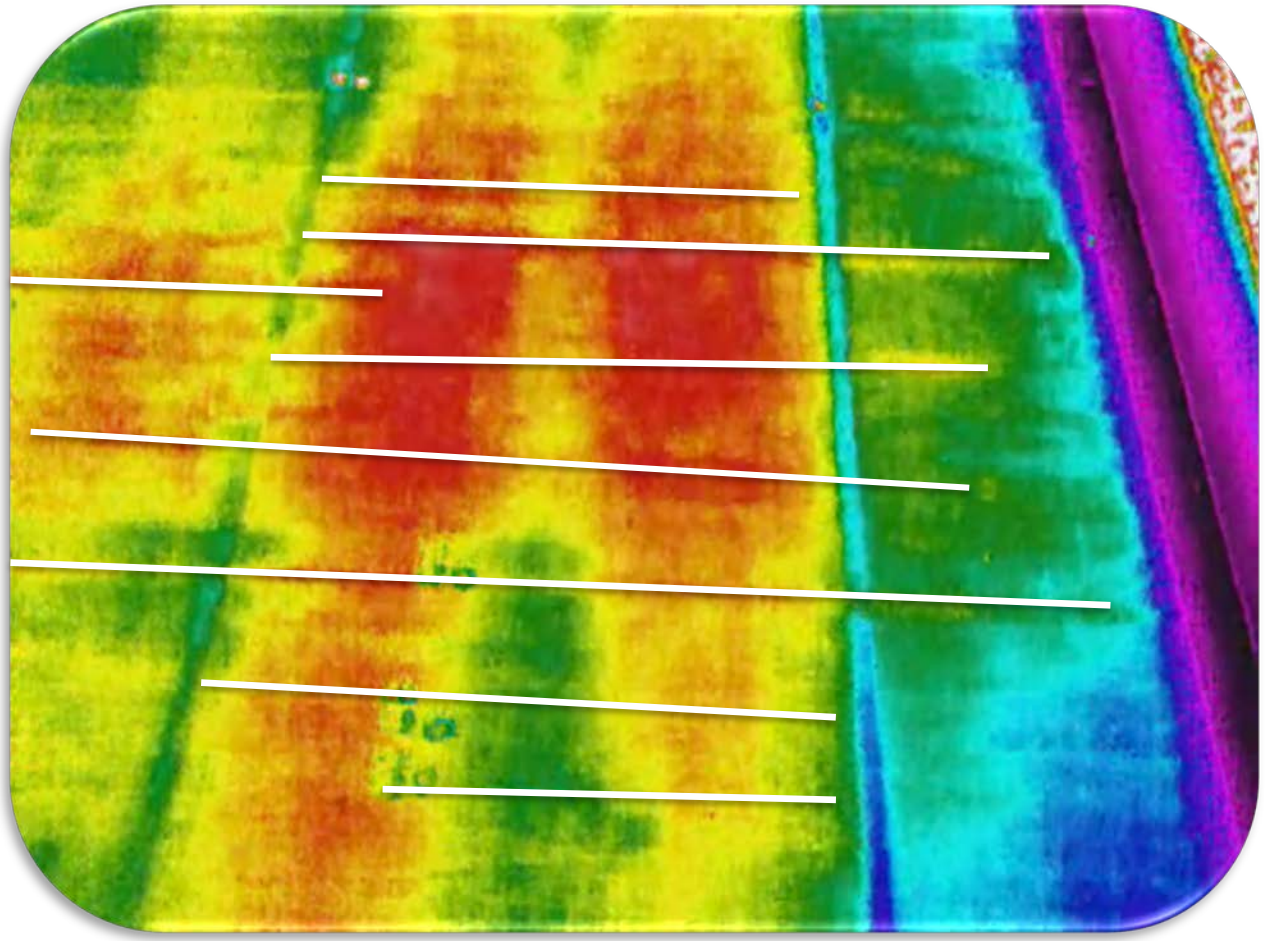
- Very little delamination noted on any of the bridges
  - Based on chain dragging and infrared images of representative areas
- Deck overlays appear to be performing well
  - 3 of the inspected bridges had overlays (as opposed to re-decks)
  - Much less cracking – transverse cracking 5 to 8 feet apart
  - Very little delamination noted
  - Overlays appeared to be cementitious/silica fume mix

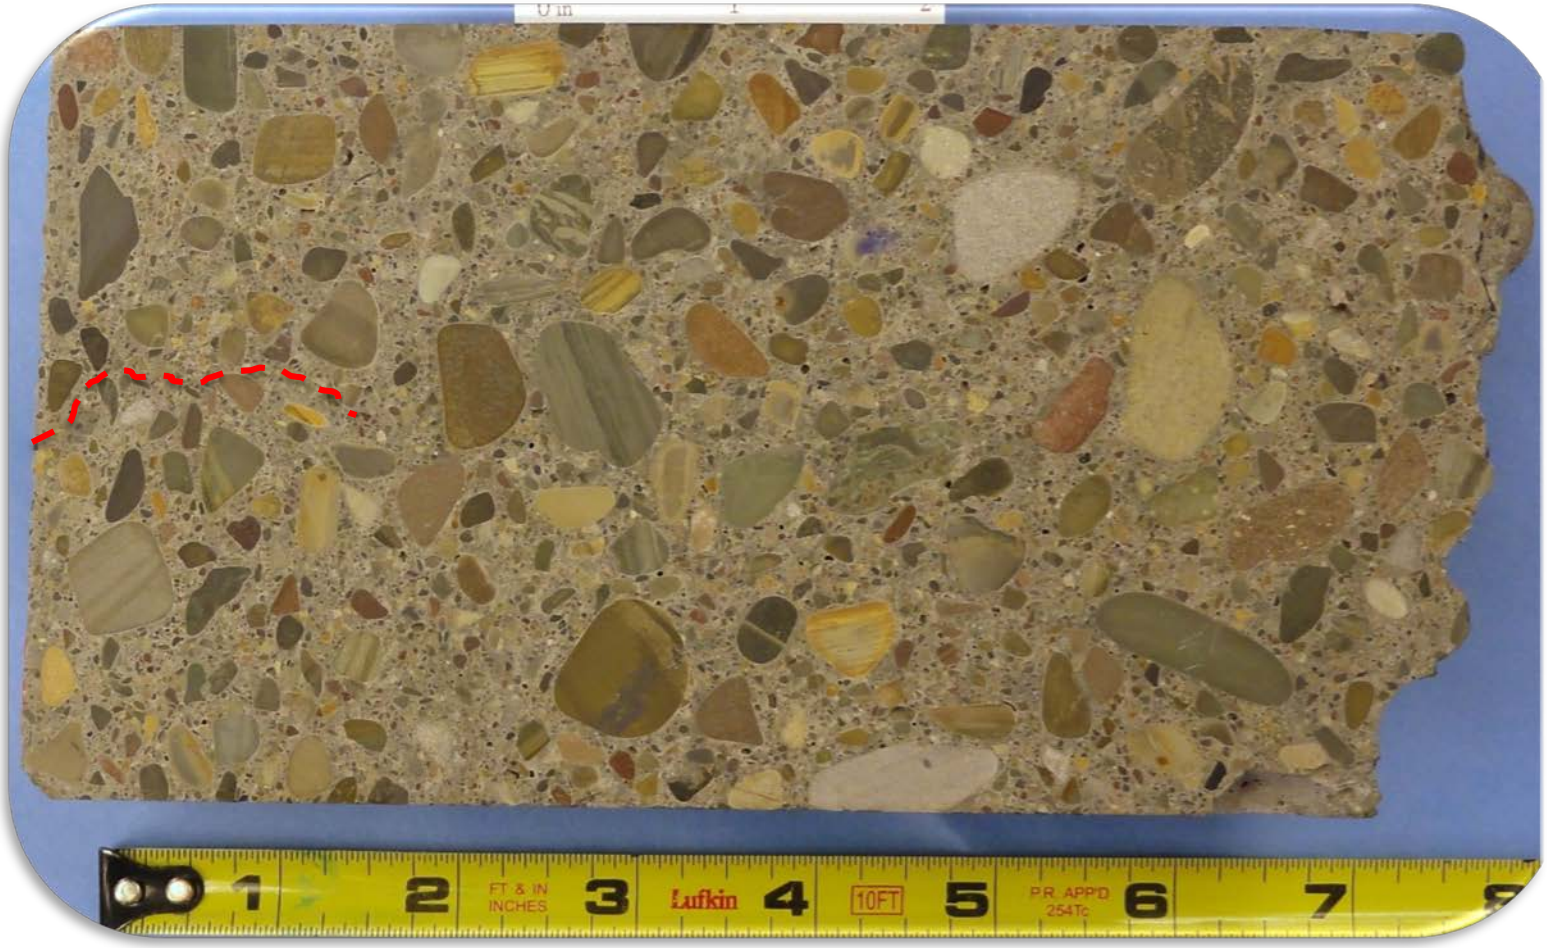
Laboratory Evaluations

- Concrete Core Extraction
  - A total of 43 cores were extracted from 8 bridges
  - Cores were extracted over “jump” cracks, transverse cracks, and no cracks
  - Tried to capture progression of cracks
  - Sampled from decks with straight cement and SCMs
  - Sampled from two overlay bridges
  - Varying severity of transverse cracks

- All transverse and “jump” cracks appeared to have initiated very early – cracks propagate around aggregates
- No signs of internal distress
- Air void system is good for freeze/thaw durability
  - Excessively high on some cores – 12%
- Aggregates are sound
- W/cm ratios were adequate, occasionally slightly elevated

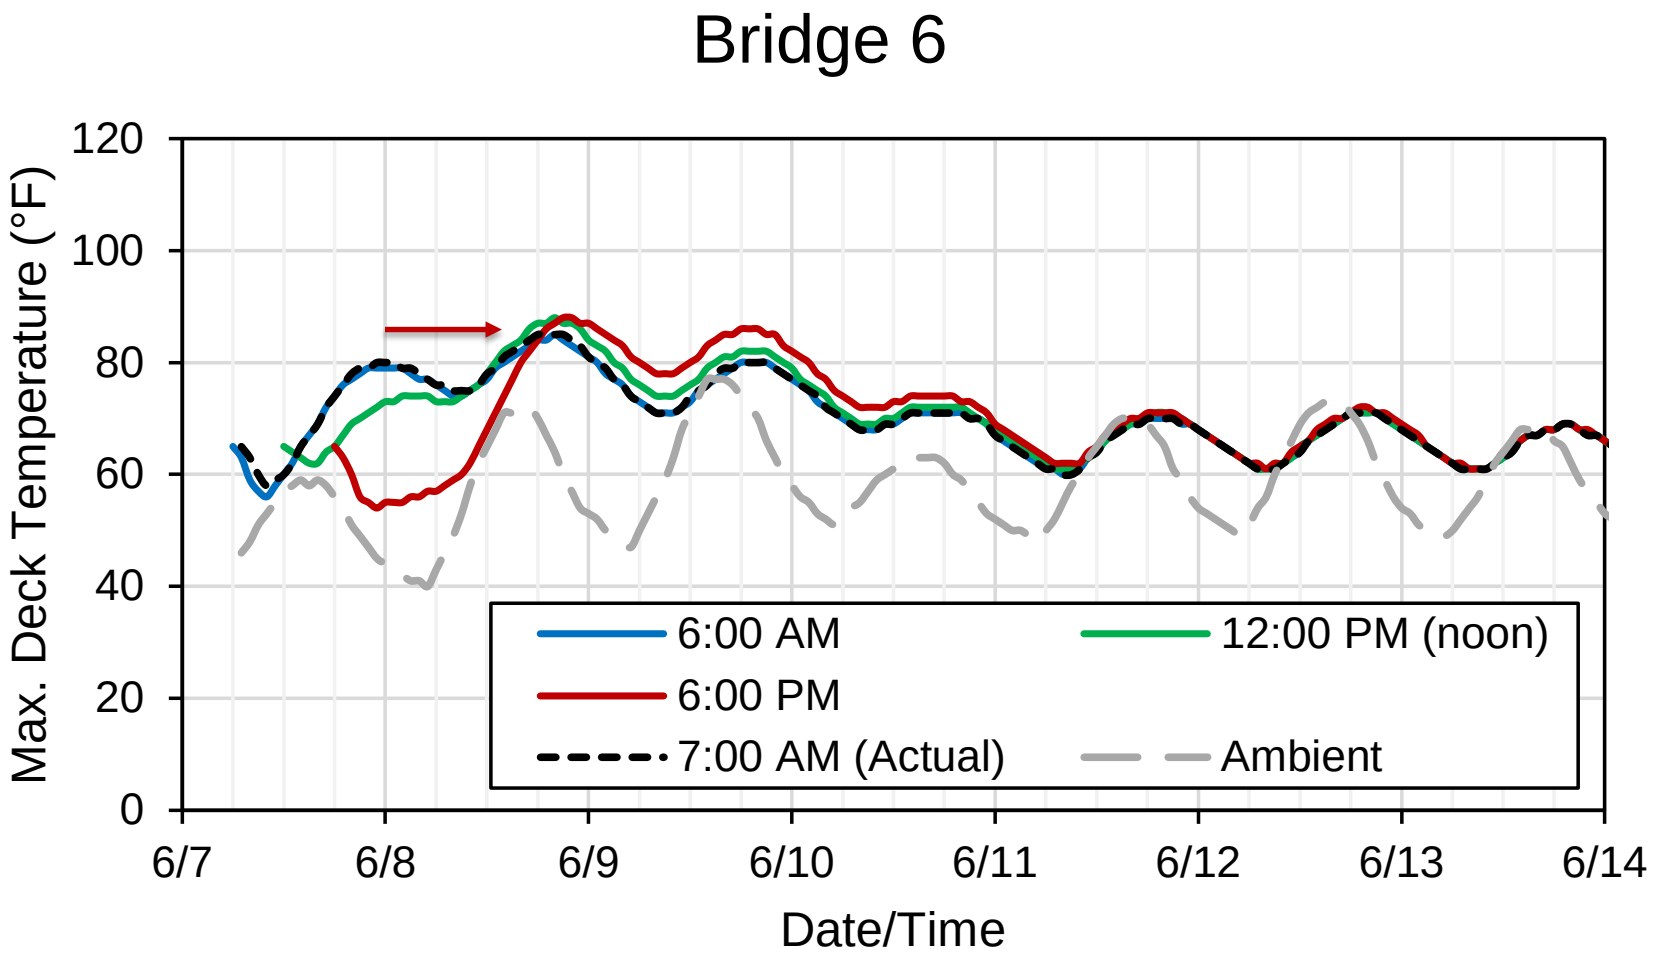
Placing concrete in late afternoon shifts peak temperature difference to Day 2 or 3.

- Move placement times to afternoon
  - Based on modeling, late afternoon likely best
- Prevents peak hydration temperatures to occur during peak ambient temperatures
- Moves peak concrete temperature to 2 to 3 days later - concrete has higher tensile strength
- Peak concrete temperature aligns with cooler night temperatures
